LOWER CONNECTICUT RIVER BASIN
BERLIN , CONNECTICUT

KENMERE RESERVOIR DAM
CT - 00251

PHASE I INSPECTION REPORT
NATIONAL DAM INSPECTION PROGRAM

FEBRUARY 1980

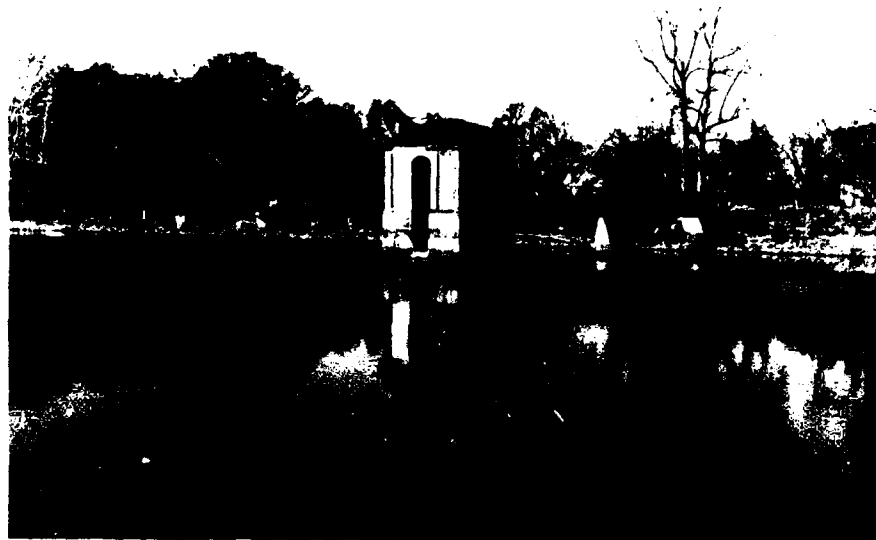
1) Upstream slope - The exposed part of the upstream slope of the main dam is partially covered with riprap. (Photo No. 1 and Photo No. 2) The riprap only extends approximately halfway up the slope from the reservoir surface and is missing or has been eroded away at many locations. Numerous tree stumps up to 3 ft. diameter were observed on the upstream slope. (as shown on Photo No. 3 and Photo No. 4)

PHOTO #1: Upstream face of dam from dike.

4) Design and oversee the repair of erosion on the upstream slope of the dam and the installation of required erosion protection measures.

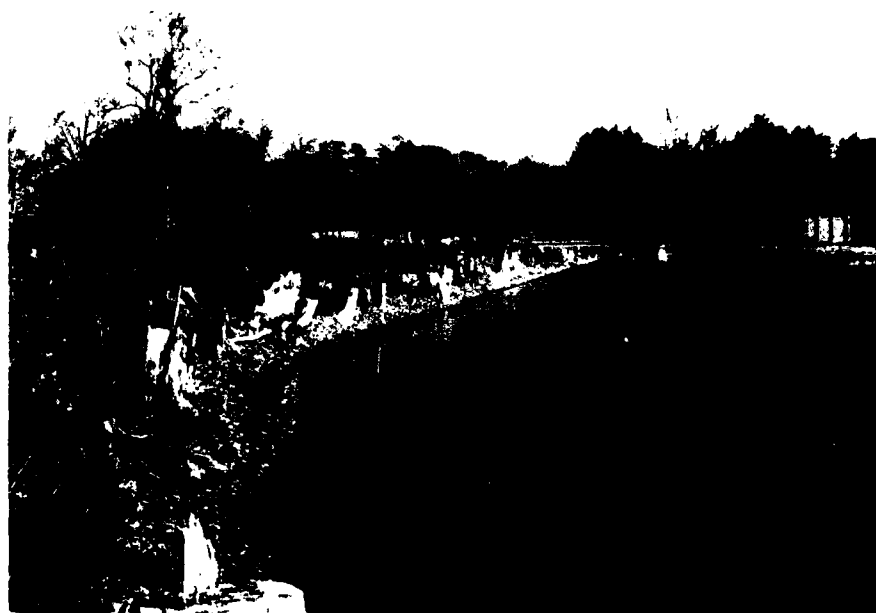
PHOTO #3: Upstream face of dam from vicinity of spillway.

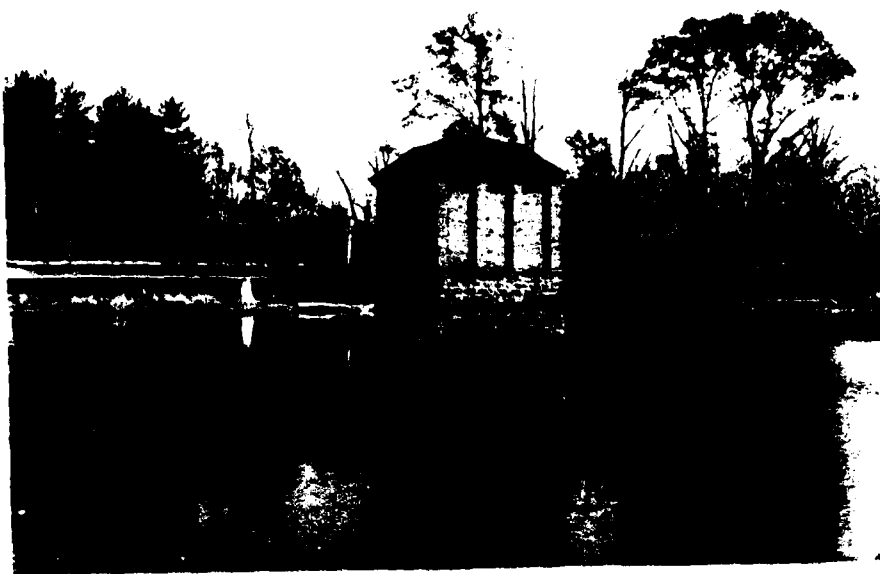
c. Appurtenant Structures. The freestanding control tower is in disrepair. The plywood floor is unsafe. Two valve stems without operator handles were observed extending to the floor.

f. Footbridge. The prestressed concrete T-beam that serves as the access bridge to the control tower is deteriorating and steel reinforcing bars are exposed. The bridge is in generally poor condition.

PHOTO #7: Gatehouse and service bridge.

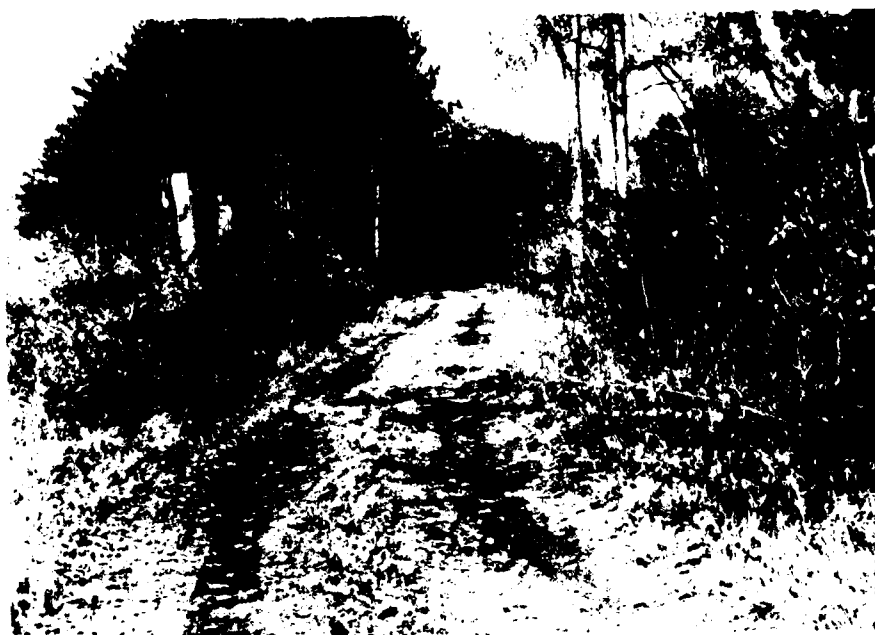
trees and stumps as shown in Photo No. 12. No riprap was observed on the upstream face. Photo No. 13 shows the unprotected earth face and a typical large tree stump that was noted. An access road traverses the crest of the dike as seen in Photo No. 14.

PHOTO #14: Crest of dike from right (east) side.

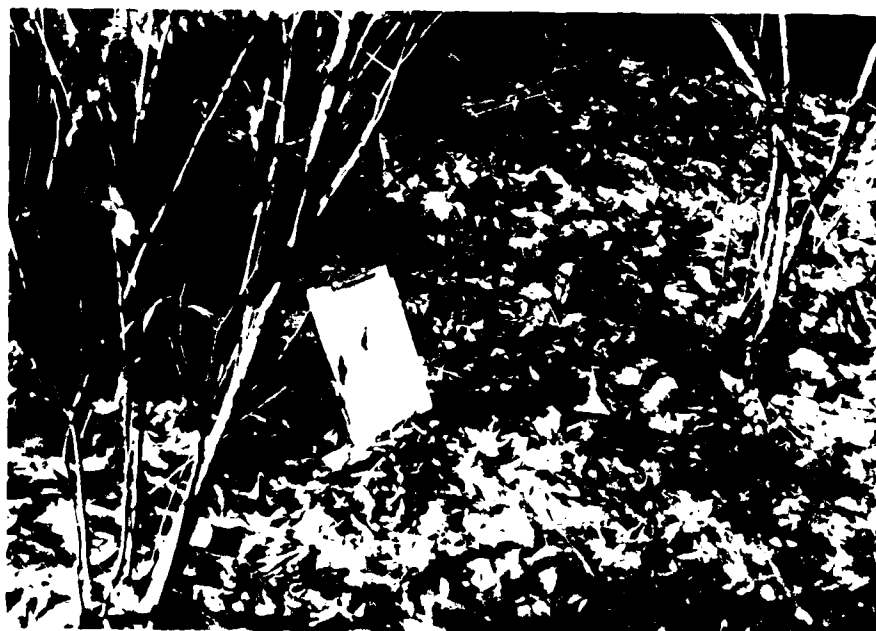
PHOTO #16: Toe of slope at Sta. D5+0. Standing and flowing water.

toe of the main dam and dike should be investigated and appropriate recommendations for remedial measures developed and implemented. The investigation should also determine the quality of seepage and turbidity associated with the discharge.
